Abstract:

The 1985 Corvette manufactured by General Motors contained a beam in the driver's side door to resist penetration and protect the driver. The beam was supported by seven spot welds at the hinge in the door frame. During an accident, the welds were unable to withstand the proper load bearing and separated upon impact and indirectly caused the driver to sustain fatal head injuries. If the welds were properly joined the beam would have remained intact and would have been able to bear the load caused by the accident.

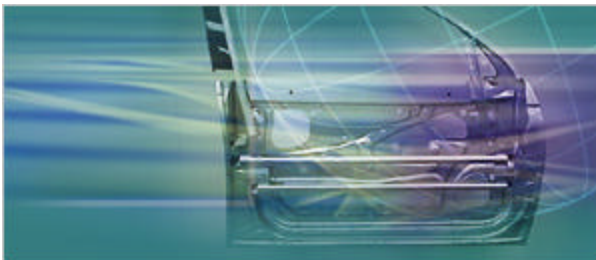
After an analysis of the car, it showed that the beam in the driver's side door had not remained intact during the accident. The high strength, low alloyed steel beam inside the door was used to increase rigidity and help buffer passengers from side impact (Figure 1). The beam was made to absorb a lot of energy and therefore reducing the amount of energy transferred to the occupants.

Figure 1: Side impact beams in the complete door frame.

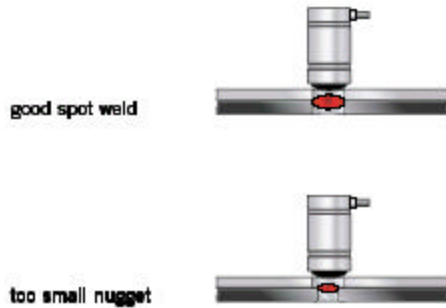
quality of the material to be welded. Production quality is determined by the porosity, penetration thickness, and the size (diameter) of the weld (Figure 3).

Figure 3: Good weld vs. defective weld
